EXPERIMENTAL STEEL PILE GROINS, PALM BEACH,
FLORIDA

11 May 1944

BEACH EROSION BOARD
OFFICE OF THE CHIEF OF ENGINEERS

TECHNICAL MEMORANDUM NO. 10

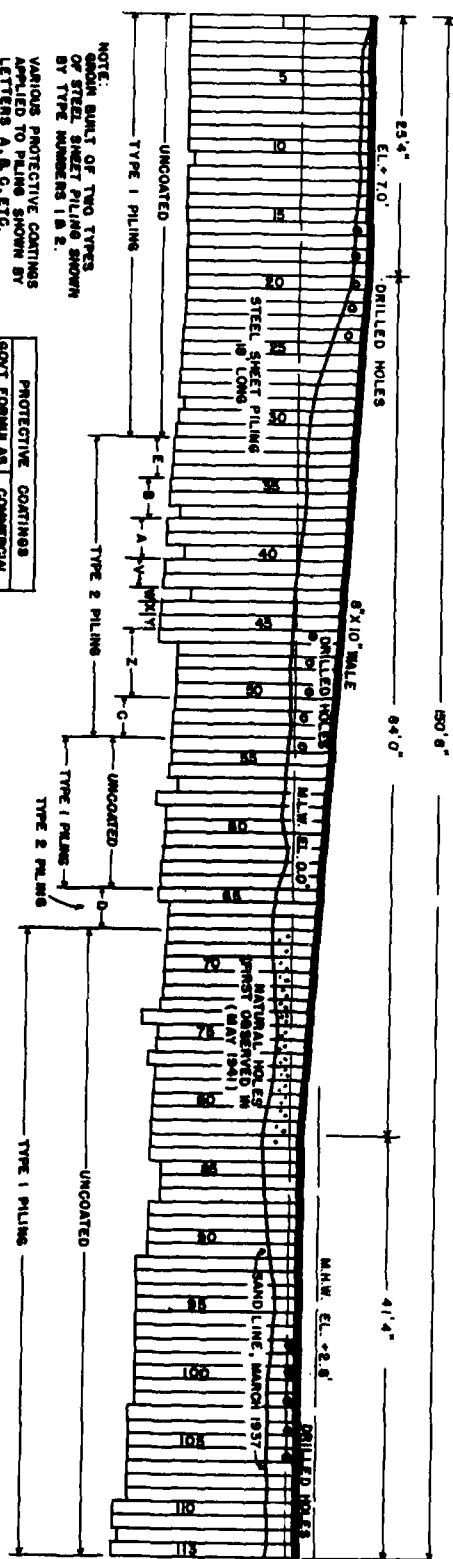
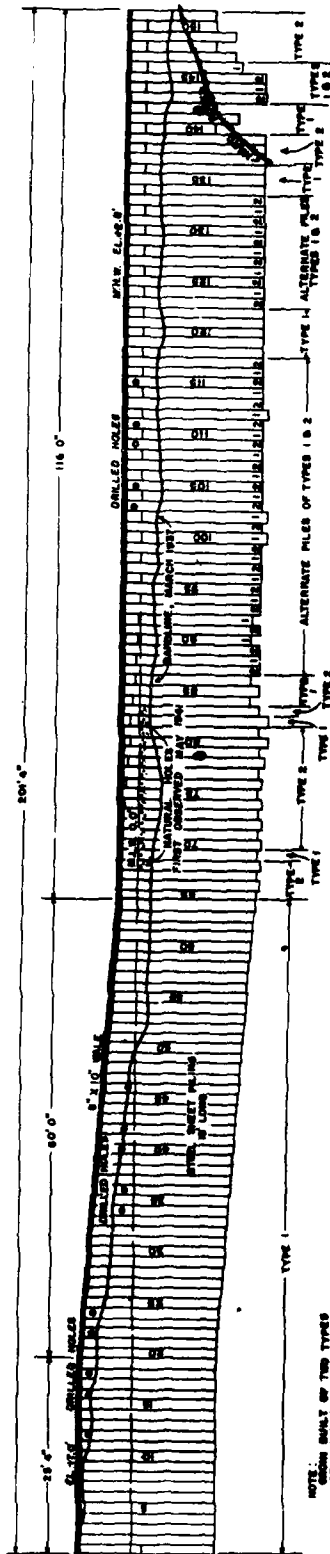
EXPERIMENTAL GROIN 139N
FIG. 4

May 1941. For the first time, holes are observed in the piles at the sand line in the interval between 90 and 110 feet seaward of the bulkhead. See Figure 4. Traces of commercial coatings V, W, and X are still evident on the exposed groin surfaces, but the other coatings have disappeared completely.

17. Protective Coatings. The commercial and government specified coatings used on Groins 139-N (Figure 4) and 112-N (Figure 8) disappeared from the exposed portion of the piles for all practical purposes in less than six months.

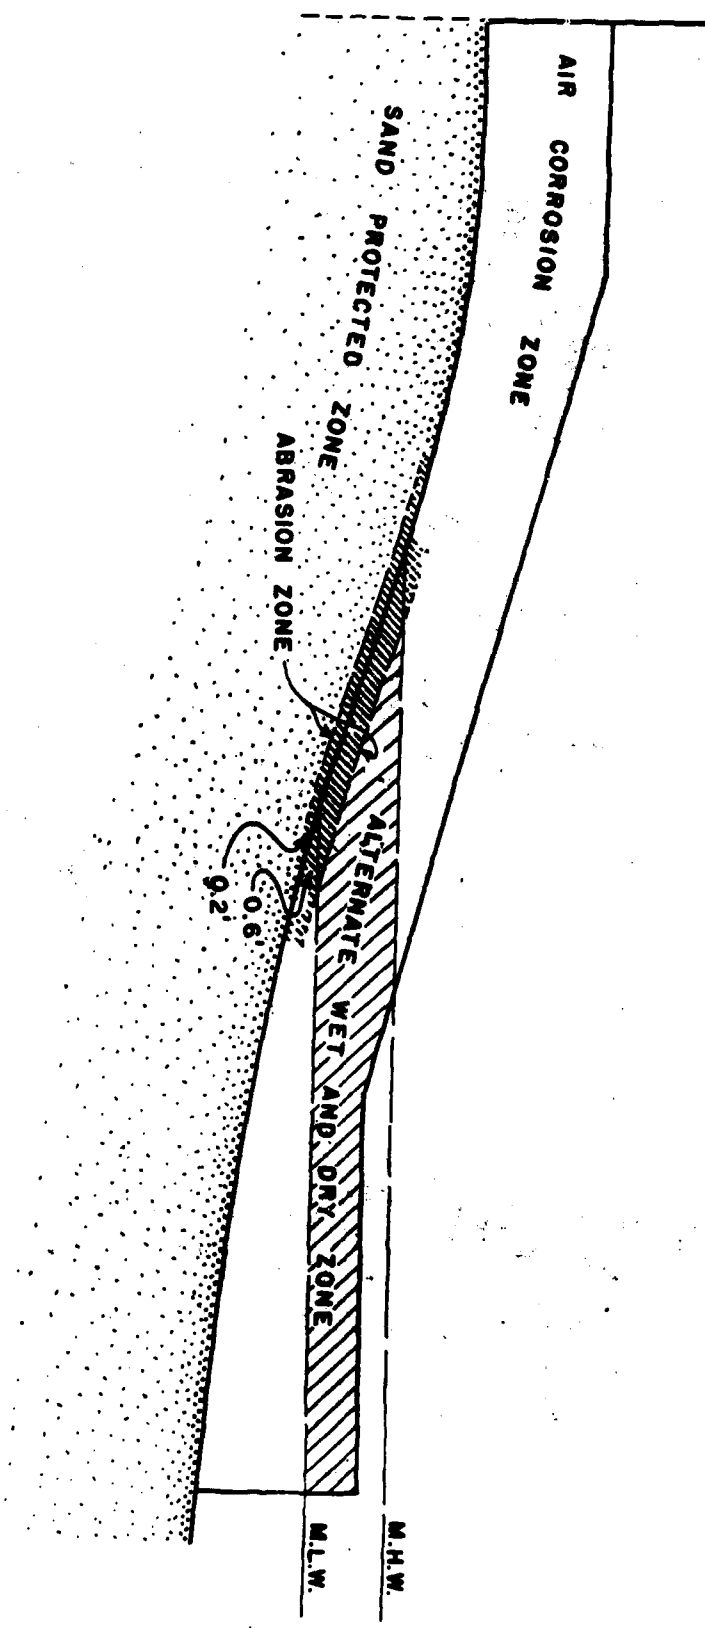
CONDITIONS OF GROIN EXPOSURE
FIG. 9

32. The location of the naturally perforated holes in the piling, the thinness of rust and frequent appearance of bright polished metal at the sand line shows that the beach material moving under wave action is the primary factor in the rapid deterioration of steel piling at Palm Beach. The principal wear on the piles occurs in a zone a few inches above and below the sand line. Abrasion by the sand continually removes the rust covering and re-exposes the bare steel to oxidation, thereby accelerating corrosion. The moving sand may also abrade the steel. Based on visual observation at the site of the experimental groins, the zone of rapid abrasion appears to be usually an inch or so wide and extends from near the upper limit of wave uprush seaward to depths greater than one foot below mean low water. Its position changes frequently as the sand line adjacent to the groin fluctuates. In order to take into account these fluctuations, the abrasion zone was arbitrarily taken as extending from 0.2 foot below the sand line to 0.6 foot above as shown in Figure 9.

34. The results of the field test show, rather conclusively, that the loss of steel from those pile surfaces in the other three zones shown in Figure 9 is much less than in the abrasion zone. The degree is indicated by the computed average annual rate of 0.011 inch for the air corrosion zone, 0.005 inch for the wetting and drying zone, and 0.001 inch for the sand protected zone.
